# Project Profile

## Selhall Housing Group

**Project:** Flat Roofs

**System:** Acrypol +

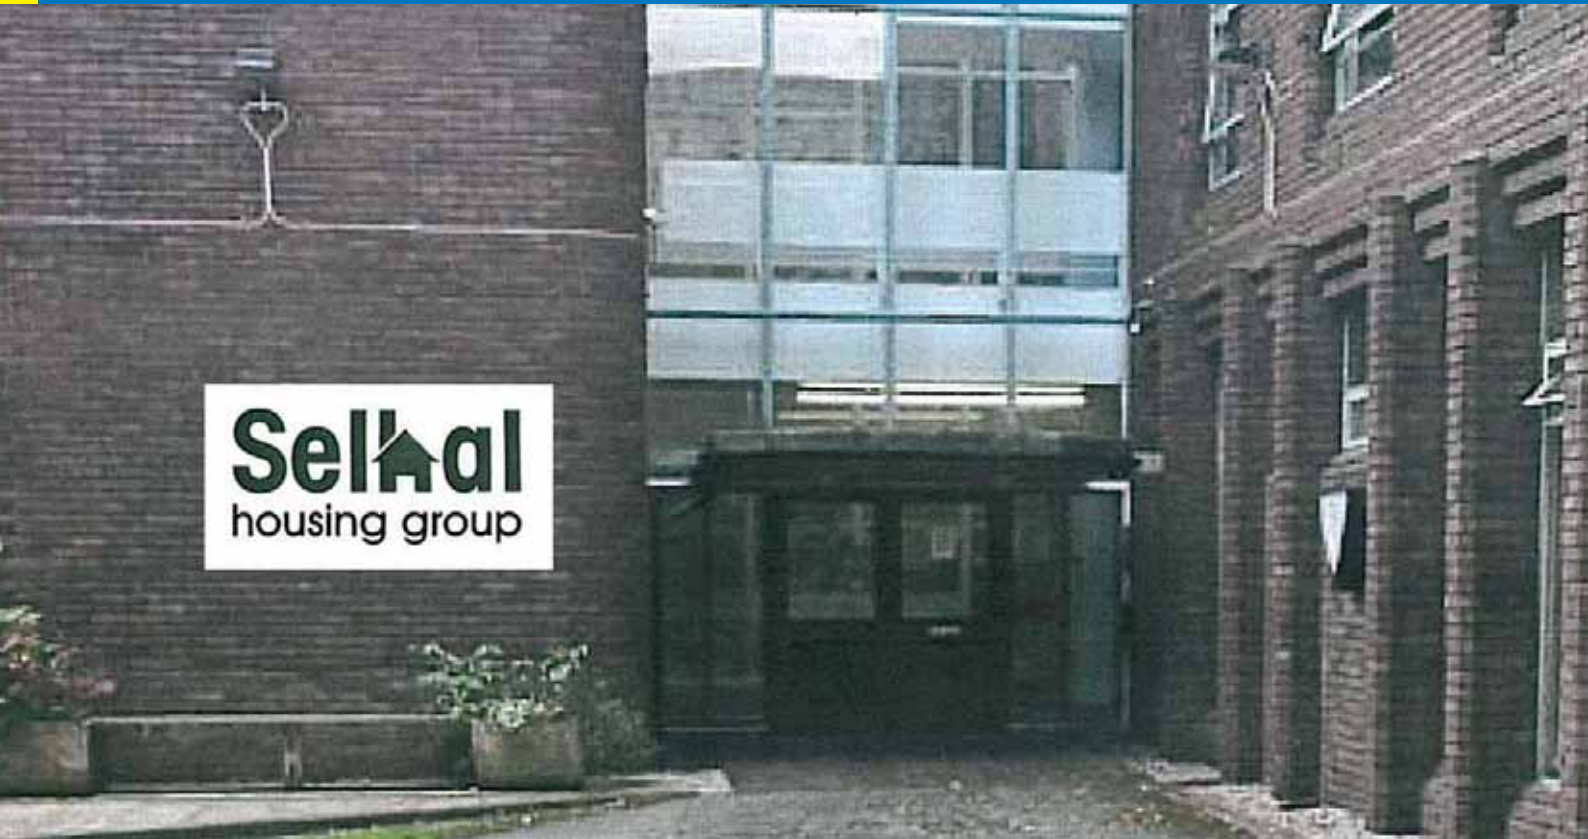
Acrypol was called in to assist Selhall Housing Group in Cheshire with a supported housing scheme that demanded immediate attention to flat roofs showing signs of failure and running the risk of leaking into the dwellings below.

Acrypol Products, working in partnership with the Housing Association's Maintenance Surveyor suggested a five-layer specification that could be installed exceptionally fast minimising any long-term damage to the properties. First the roof was cleaned and sealed. Two layers of Acrypol then sandwiched a high performance scrim/matting layer which is specially designed to toughen and reinforce the new roof's surface. A top layer of Acrypol + in white was then installed to complete the process.

The 700sqm roof took less than two weeks to complete, encapsulating the failing roof area and ensuring the waterproof integrity of the homes whilst making considerable savings when compared with re-roofing using more traditional materials.
